2014 Leak Autopsies

Mike Trombetta, DEQ

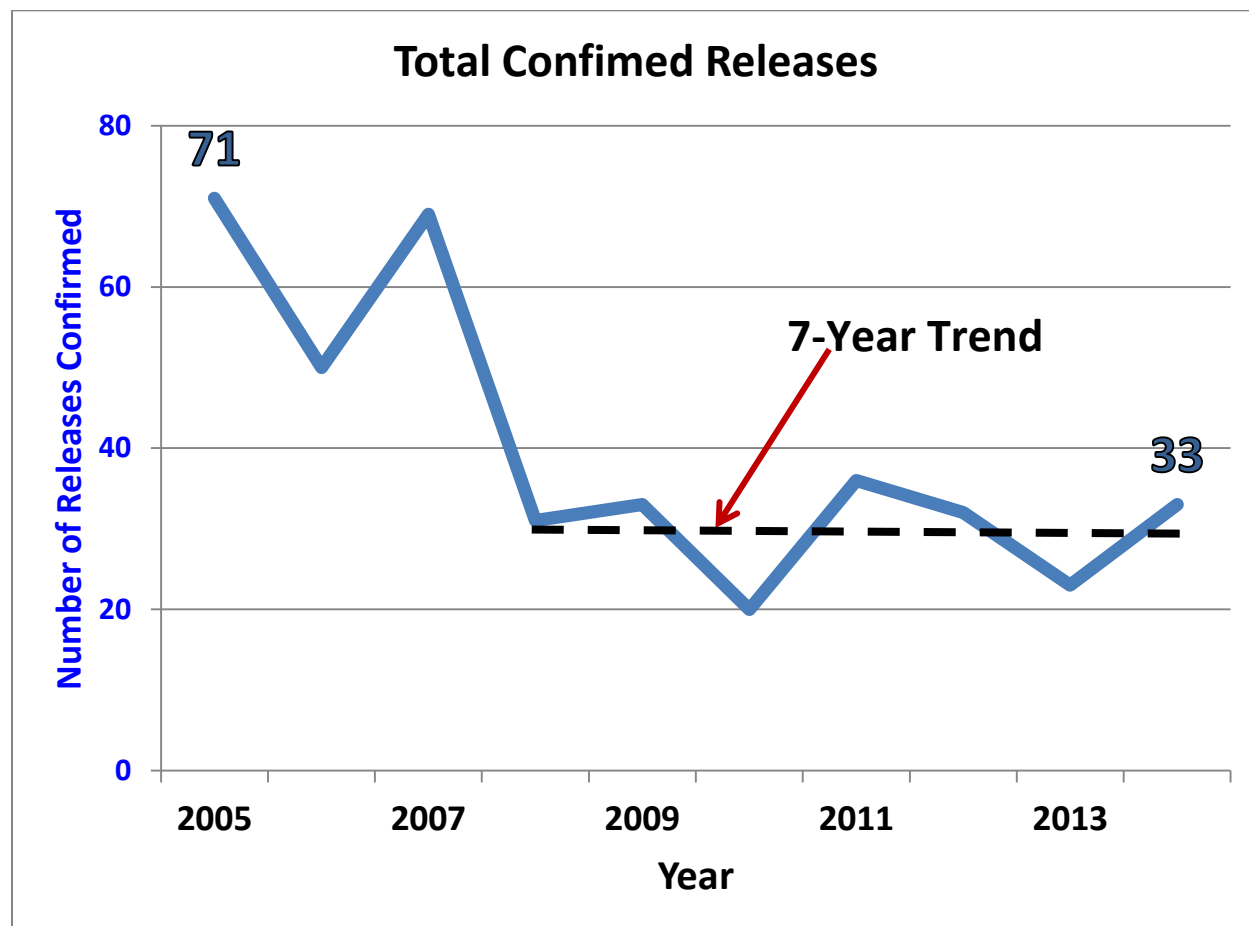
Montana's 33 confirmed petroleum storage tank releases in 2014 is up from 23 new releases the previous year. However, this is right in line with the fairly flat trend of about 30 new releases confirmed each year since 2008.

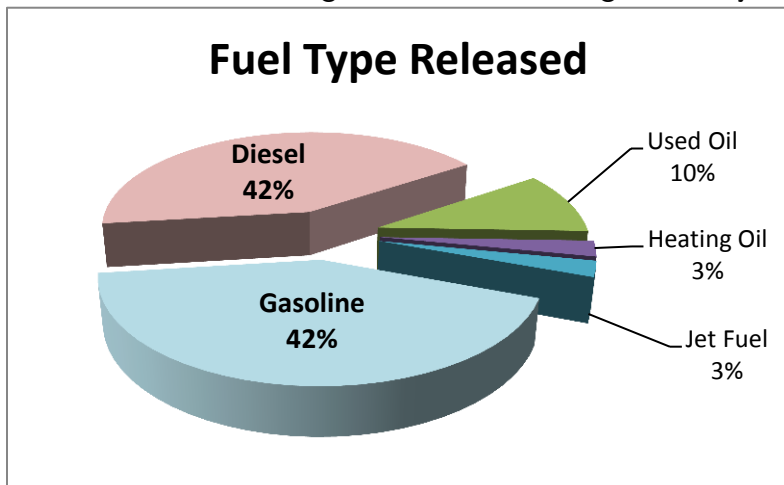
The majority of the fuel types released were split equally between gasoline and diesel, with a minor smattering of used oil, heating oil, and jet fuel.

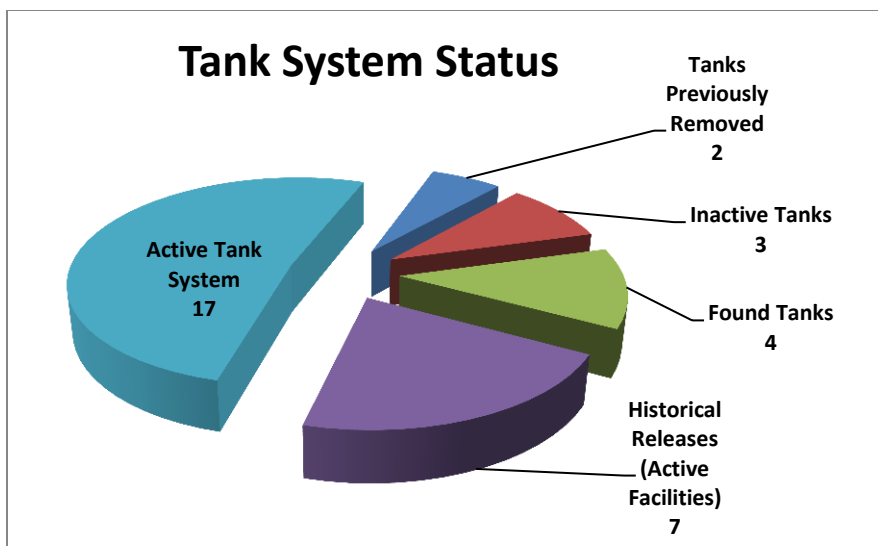
Seventeen, or a little over half, of these releases originated from active tank systems, with the remainder coming from historical releases, "found" tanks, or inactive (sub-standard) tanks.

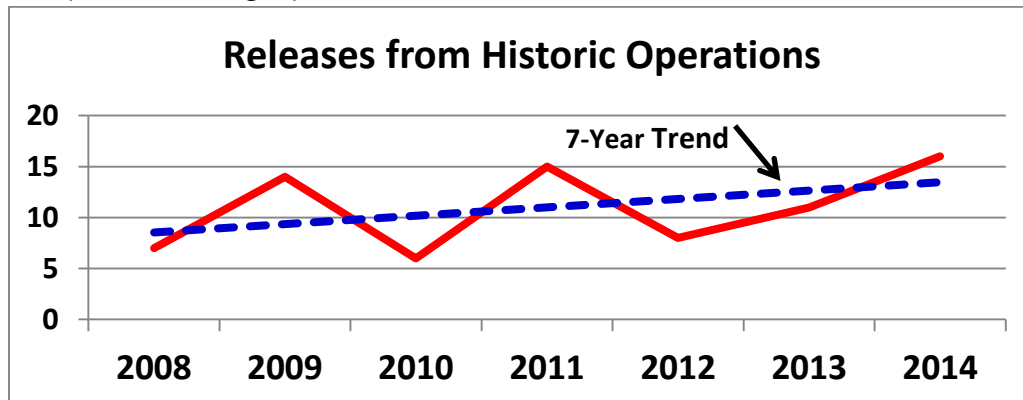
The number of releases from other than active tank system has risen to its highest number since 2007, at 16. This is consistent with the seven-year trend that shows a continuous rise in these types of non-active sources, but is unexpected since the number of historical releases and unfound tanks is finite, and must also be getting smaller as we discover them. This increase could very likely be due to increases in construction projects and property transactions. Six of these releases were found through environmental assessments (typically associated with land sales/development), and four were discovered through on-site and off-site construction projects.

It is also worth noting that seven historical releases were discovered at facilities with active storage tanks. Although petroleum storage systems were currently operating at these sites, DEQ determined that the contamination pre-dated the existing equipment and was associated with older operations. This was significant enough to break it out as a separate category: Historical Releases at Active Facilities.

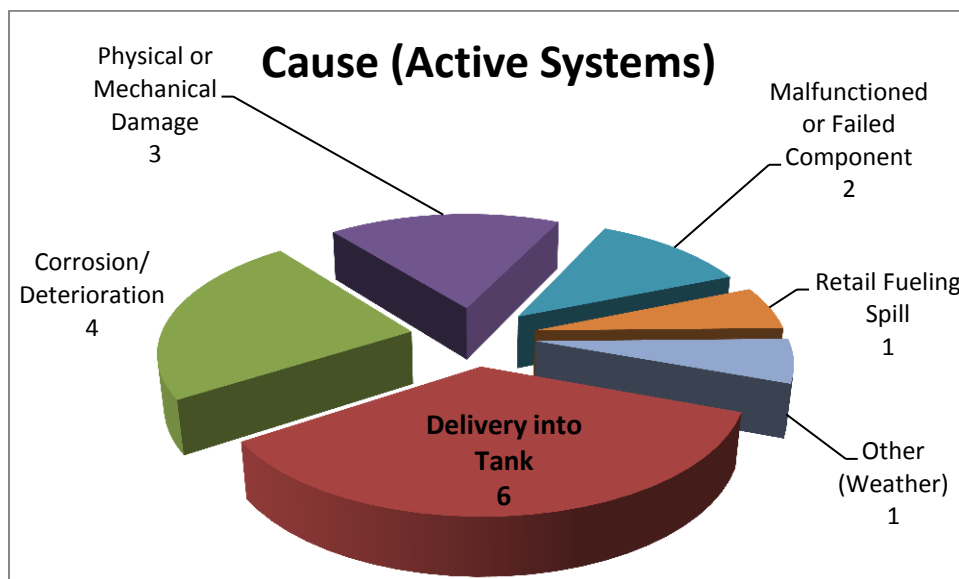
These “Leak Autopsy” reports provide good lessons learned on how to prevent future releases. Because data from active tanks provides the best information to improve current systems and procedures, the remainder of this discussion will focus on the 17 releases from active tank systems. Six of the releases involved overfilling a storage tank (UST or AST).

Five releases were caused by fuel being pumped into the wrong tank; four of which were operator error; and one was due to a malfunction in a valve relay. One downspout adapter came off while offloading into an UST. The precise cause of one

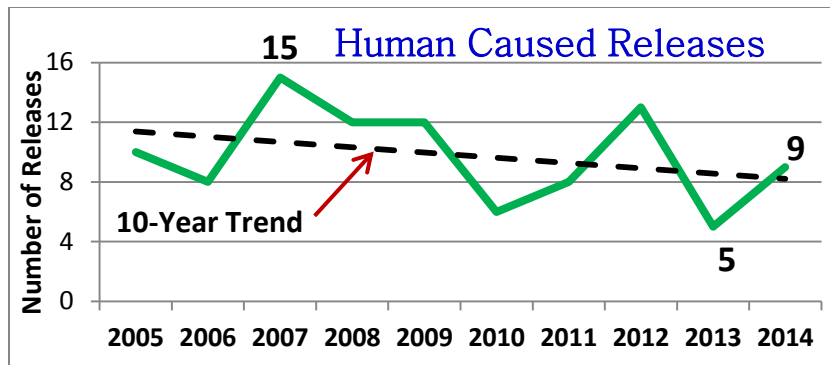
Although the ten-year trend of human caused releases is continuing to decline, this year's number of nine nearly doubles the all-time low of last year's five human caused releases. Two-thirds, or six, of these releases were initiated by errors of the facility or delivery truck operators during tanker offloading operations. This is a disturbing and continuing trend we have seen where releases are caused r by professionals in our industry each year. If operators took proper care to ensure connections are made correctly, valves are set right, and pumps are turned off following deliveries, these types of releases could have been avoided. It is also critical that operators and/or drivers stay in clear sight of the tankers and tanks throughout the entire delivery. Please be careful out there!
